# Site Observation Report

| SITE ADDRESS | SAMPLE SITE, NSW |
| SITE VISIT | 21-02-2026 |

SAMPLE RENOVATION PROJECT

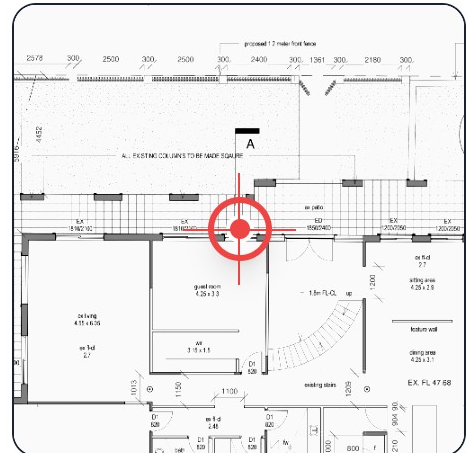
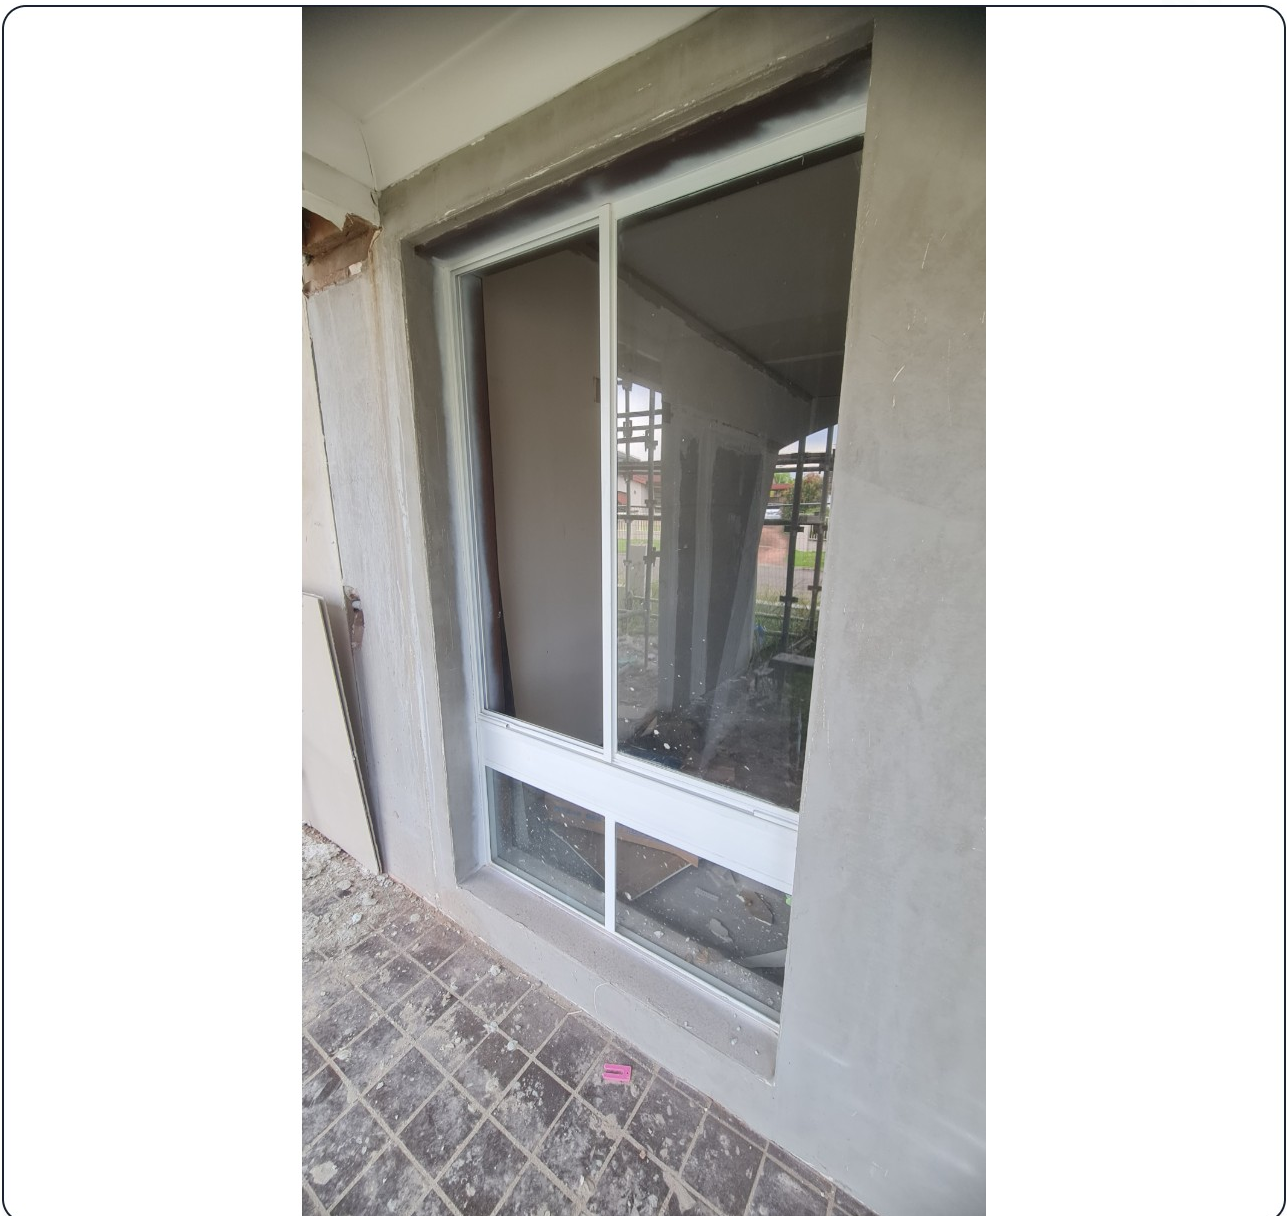
3

| #3 | ABSENCE OF A GLAZING PANE WITHIN THE WINDOW FRAME ASSEMBLY. | NO DATE | OPEN |

ABSENCE OF A GLAZING PANE WITHIN THE WINDOW FRAME ASSEMBLY.

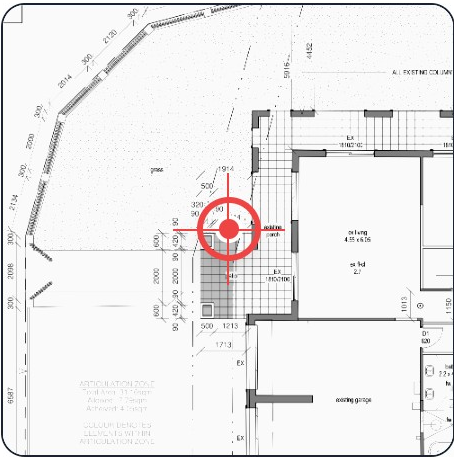
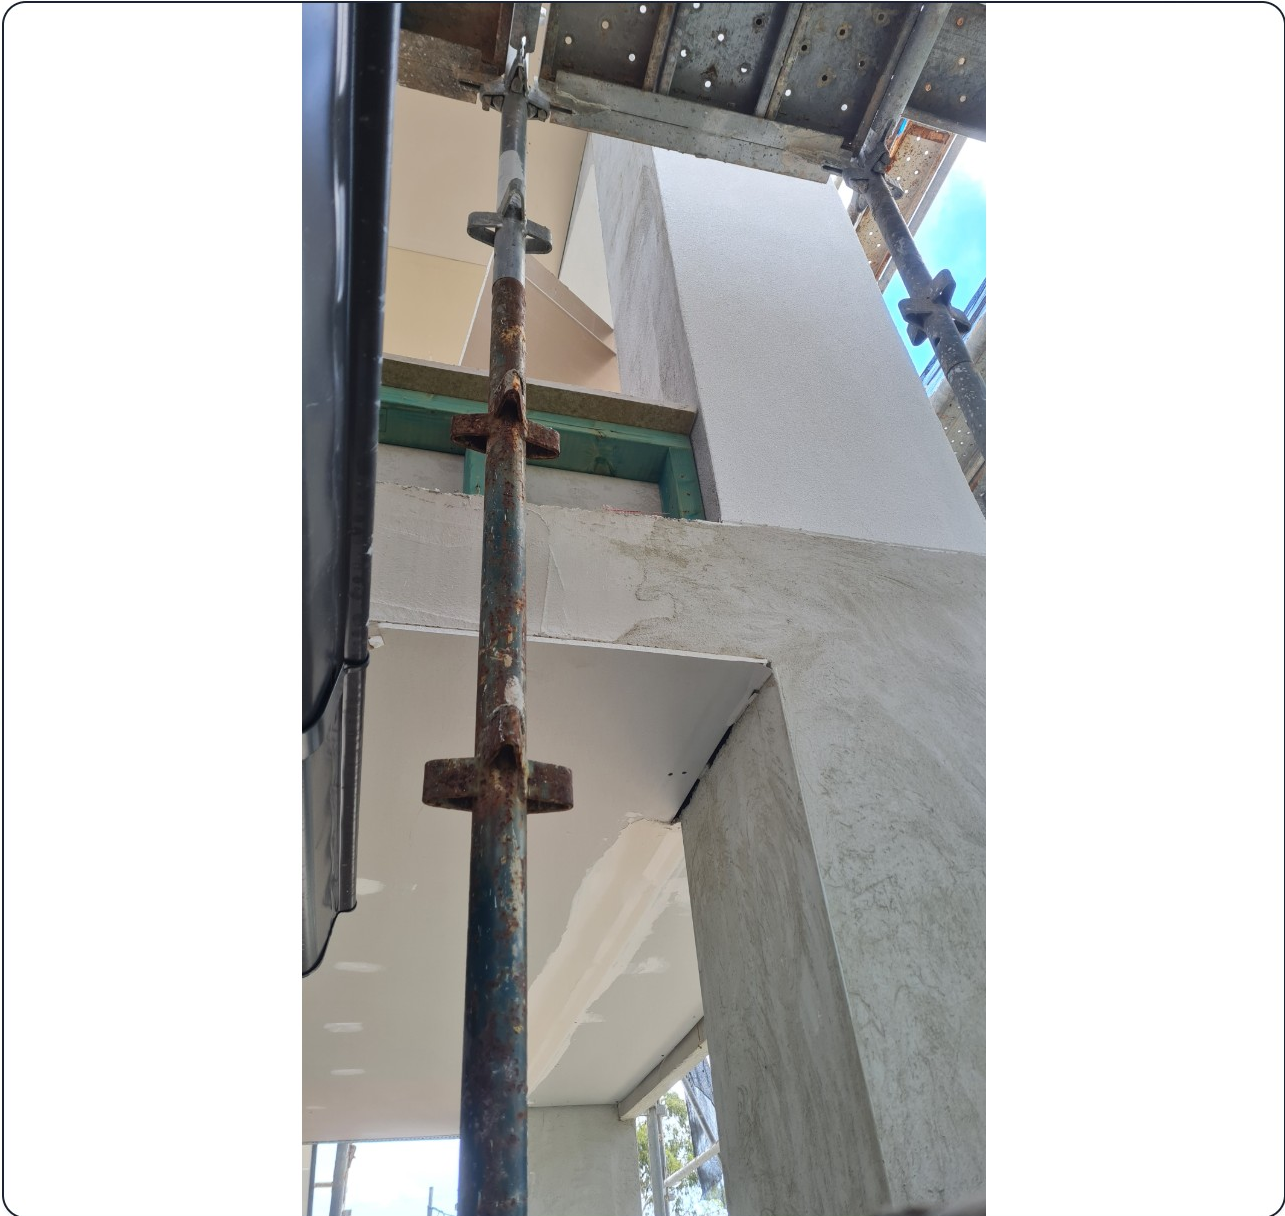
6 DISCOVERY DOSSIER

| #6 | GYPSUM PLASTERBOARD IS EXPOSED TO ENVIRONMENTAL ELEMENTS. THE INSTAL... | NO DATE | OPEN |

GYPSUM PLASTERBOARD IS EXPOSED TO ENVIRONMENTAL ELEMENTS. THE INSTALLATION LACKS A DRIP EDGE AT THE TERMINATION POINT.

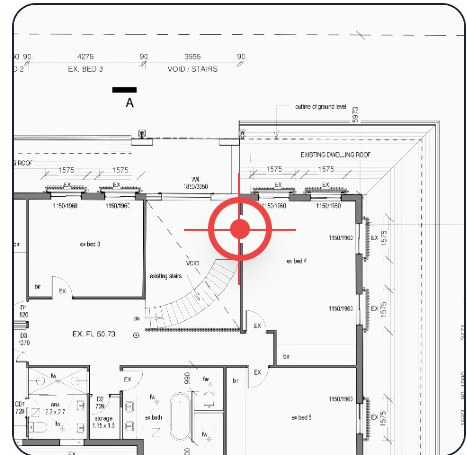
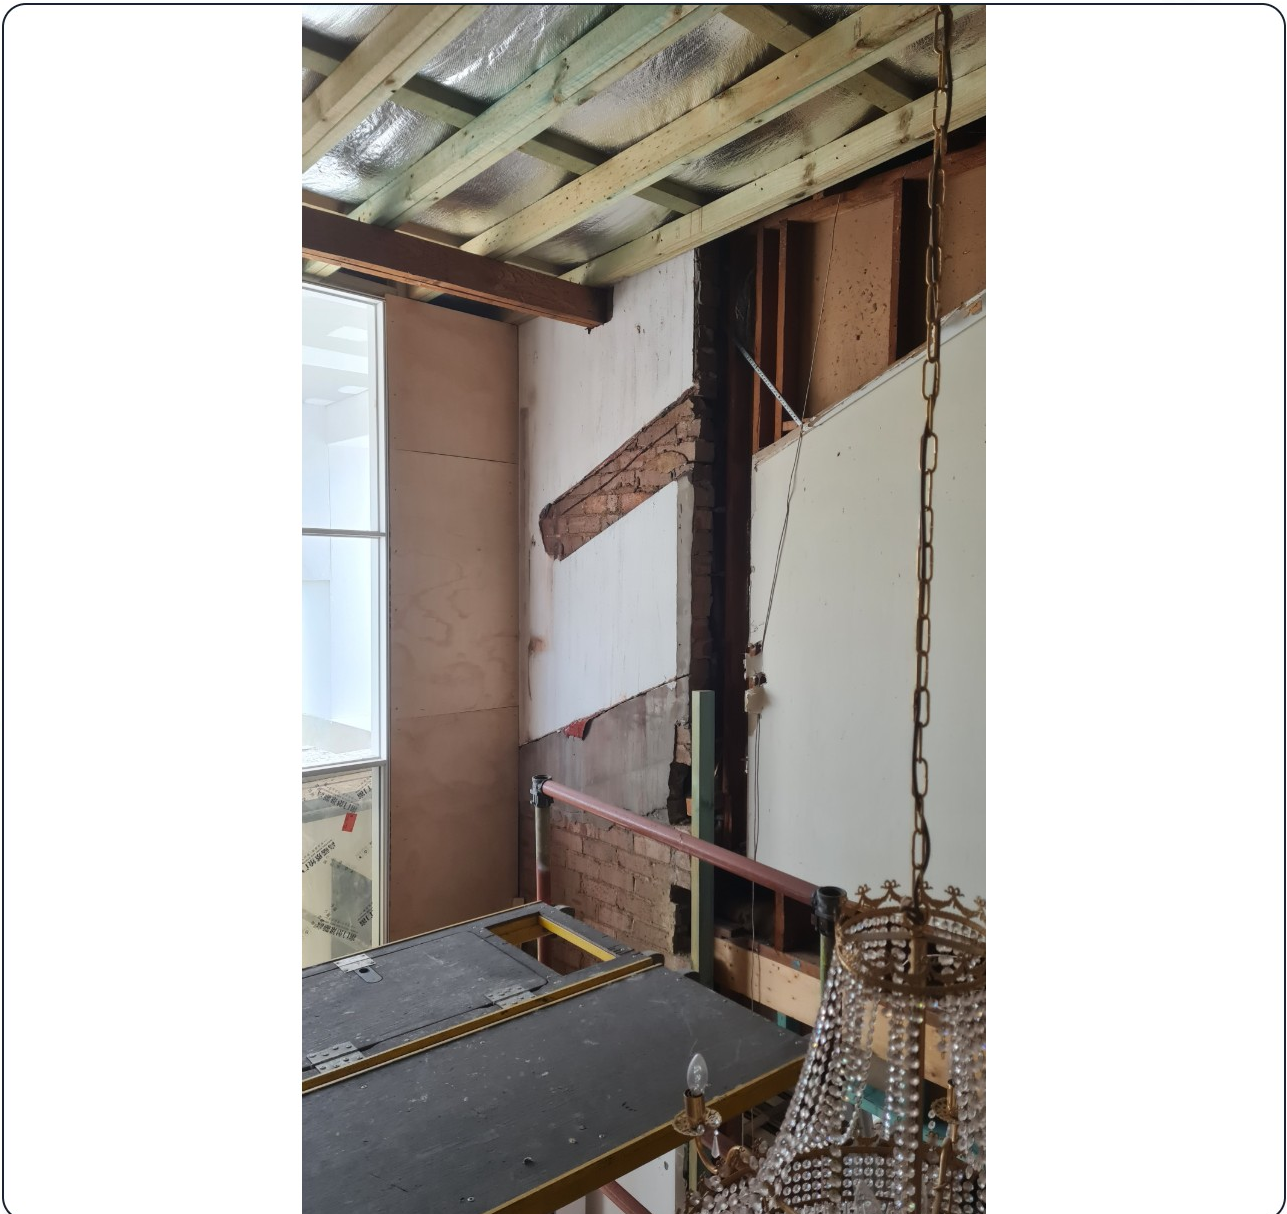
9

| #9 | THE WALL FRAMING IS INCOMPLETE AND DOES NOT EXTEND TO THE FULL LENGTH... | NO DATE | OPEN |

THE WALL FRAMING IS INCOMPLETE AND DOES NOT EXTEND TO THE FULL LENGTH OF THE INTENDED WALL ASSEMBLY.
